Article

Internal Cracks and Non-Metallic Inclusions as Root Causes of Casting Failure in Sugar Mill Roller Shafts

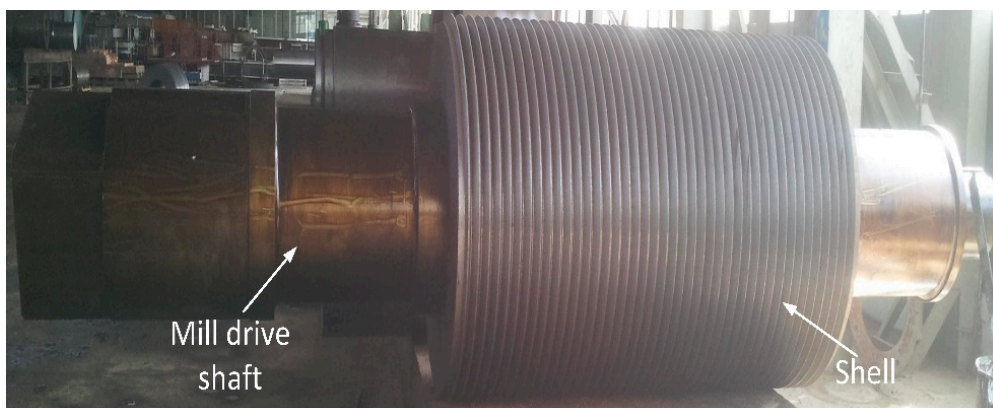
Figure 1. Sugar mill roller shaft with final groove ready for shipment.

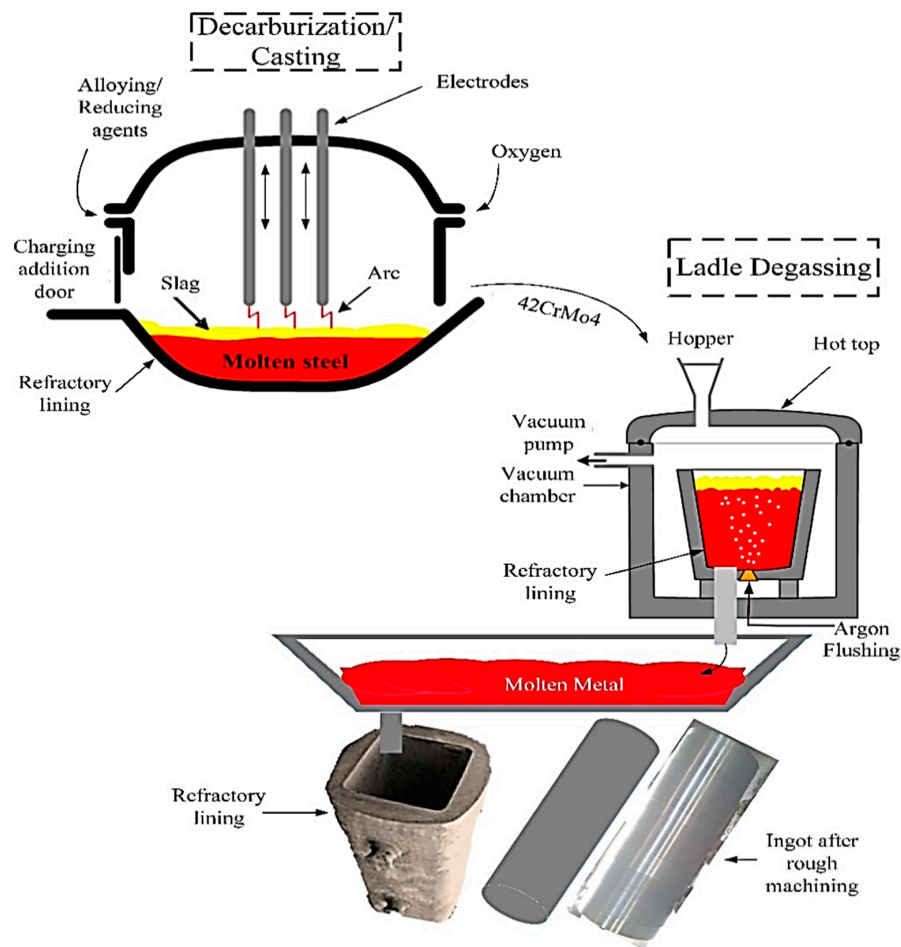
Figure 2 highlights the procedure to make the roller shaft ingot. Throughout the process, factors involved in the casting process are highlighted that can contribute to the quality as well as the rejection of the sugar mill shaft. The major sub-processes in casting are de-carburization/casting, ladle degassing, the refractory piping system, the ingot mold body, and the rough-machined ingot ready for the initial quality check.

Figure 2. Possible sources contributing to the rejection of the roller shaft.

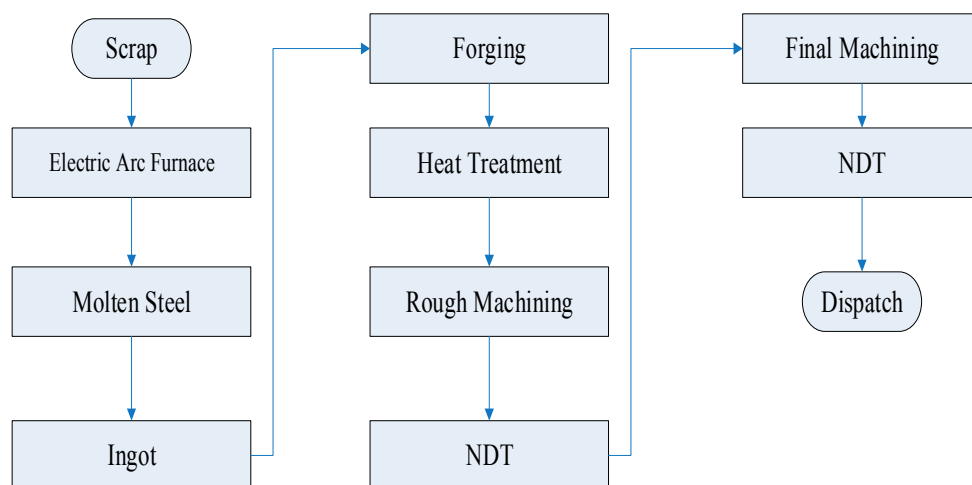
Further, rough machining was performed to remove the unwanted material as the ingot reached room temperature. Rough machining was used to attain a smooth surface to apply further quality tests to ensure that any surface/subsurface cracks and non-metallic inclusions were $< \sim 300 \mu\text{m}$. Figure 3 presents the scheme of the manufacturing process on the mill drive shaft.

Figure 3. Flow chart depicting critical processes in the manufacturing of the sugar mill roller shaft.

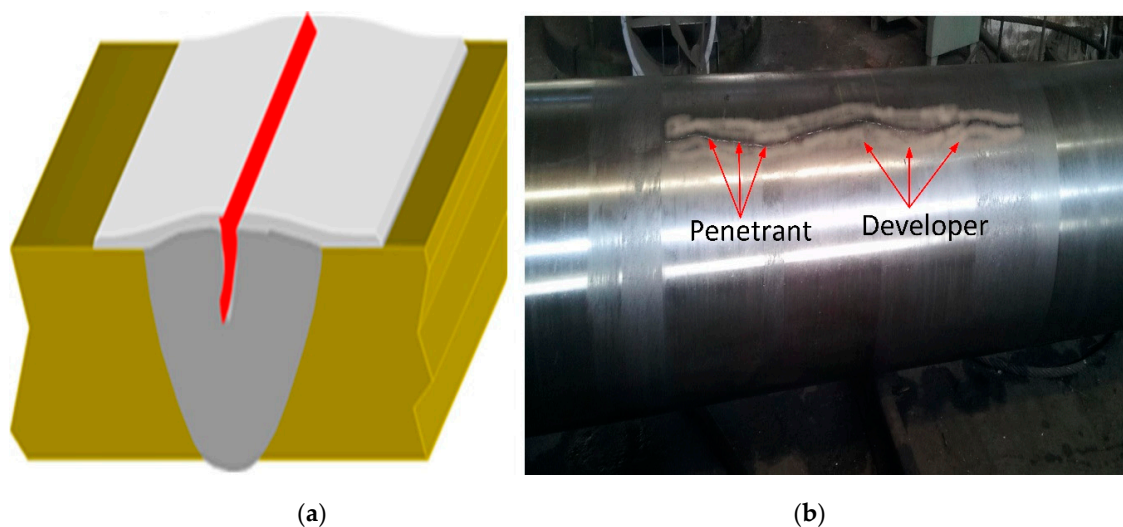
Figure 4. (a) Schematic diagram depicting the application of cleaner, penetrant, and developer; (b) Sugar mill roller shaft after penetrant testing (PT).

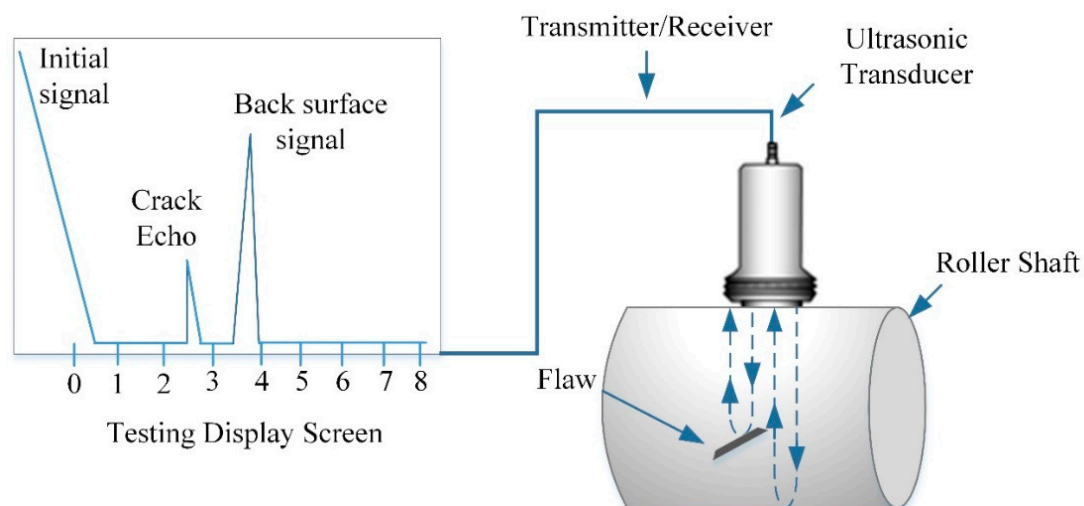
is given by $v = f\lambda$. The UT inspection system incorporates a portable probe of transmitter/receiver, transducer, and a display screen (see details in Figure 5). A pulse is generated by imposing an alternating voltage that activates a piezoelectric probe crystal to produce signals by coupling the probe to it. The sound waves emitted from the boundary of the workpiece reveal any crack/cracks that is received as feedback from the probe. Through a reverse piezoelectric crystal effect, received waves are converted into voltages and displayed on the screen. Here, an ultrasonic system was used (HY-350; Suzhou De Sisen Electronics Co. Ltd, Jiangsu, China) that permits a detection range of 0~6000 mm thickness, and a dynamic range of >32 dB, with a single probe. The sensitivity of the system is 0~110dB in order to overcome the effect caused by the surface roughness of the detected workpiece. The transducer system (HY-350; Suzhou DeSisen Electronics Co. Ltd, Jiangsu, China) production is driven by a pulser with a 2.0-MHz frequency-based ultrasonic energy. The system resolution is >40 dB. The location of the crack is obtained by moving the probe. The crack waves are produced from zero to maximum, as the probe moves from the defect-free region to the defective region. The characteristics of the crack wave obtain the location of cracks.

Figure 5. Schematic diagram of the ultrasonic testing (UT) set-up, depicting the test screen and compression probe.

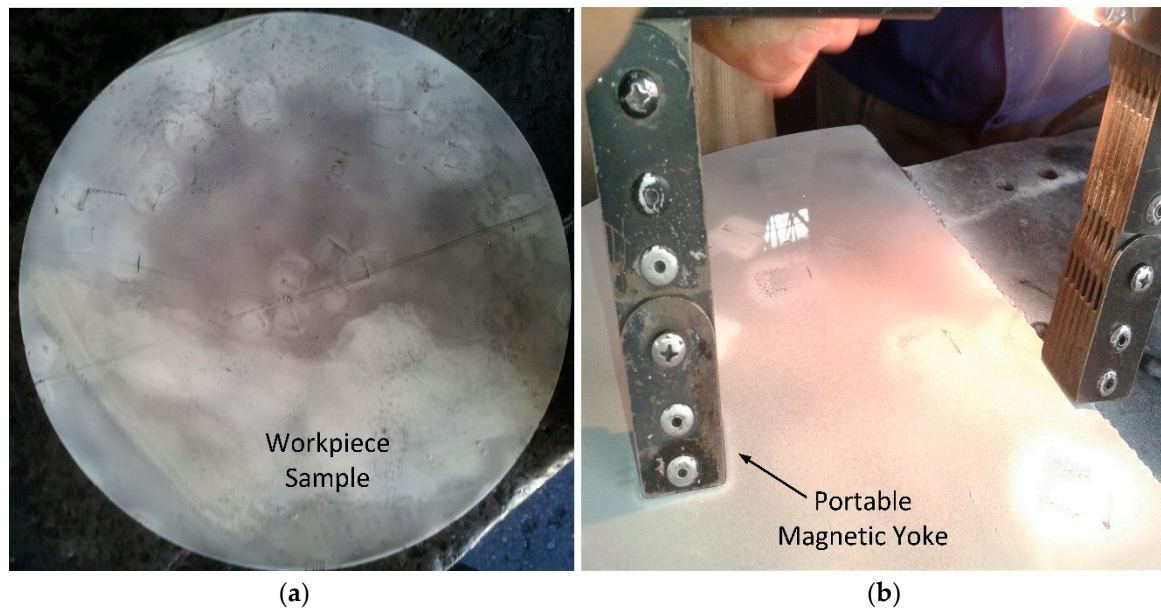
are specifically designed with properties that have flash points above 93°C and keep nocuous vapors low. High magnetic permeability is essential because it makes the particles attract easily to the small magnetic leakage fields from discontinuities, such as flaws/cracks. Fine iron particles accumulate at the poles of a magnet; however, in any discontinuity/crack, iron particles accumulate at the flaw/crack location and adopted same orientation. Low retentivity is vital, because the particles themselves never become strongly magnetized so they do not stick to each other or to the surface of the part. Due to the large diameter, MT was performed in steps to detect all the surface of the workpiece. The MT testing application set-up is depicted in Figure 6.

Figure 6. (a) Prepared sample for magnetic particle testing (MT); (b) MT yoke system to detect cracks.

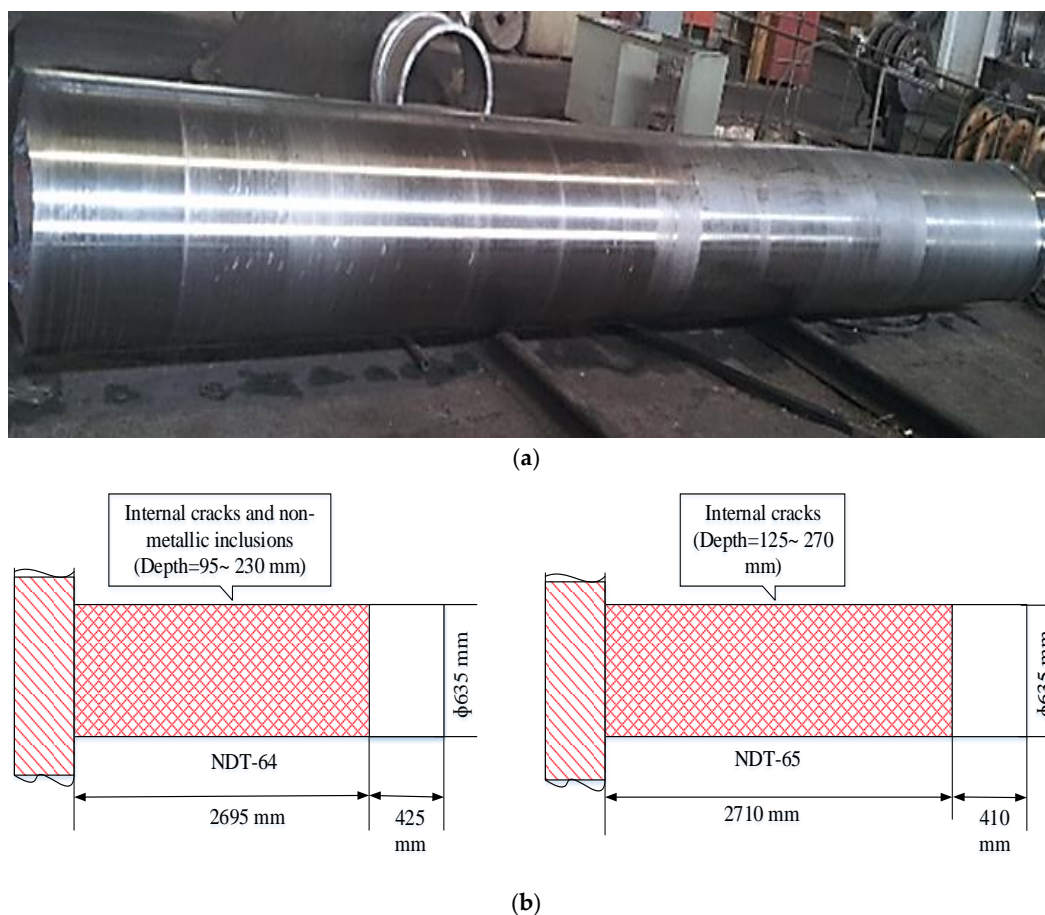
During the scanning of the component, a few indications were found to be above the DAC curve, within 12.7 mm. Based on the indication pattern, the scanned component on the DAC curve showed an indication of flaw. Ultrasonic testing precisely indicates subsurface cracks/discontinuities and the possibility of nonmetallic inclusions [36]. UT measurement was performed twice to validate the presence of cracks and inclusions. The presence of cracks was observed under the supervision of the local industry quality control department non-destructive testing (NDT-64). The NDT-64 reports of the shaft under observation showed non-metallic inclusions and deep internal cracks at a depth of 95~230 mm, randomly distributed throughout the shaft length of 2695 mm (details in Figure 7). For further clarification, UT testing was performed under the supervision of a multi-national quality control department (NDT-65). So, rejection was ensured with the identification of a flaw with its position. NDT-65 depicted internal cracks within the depth of 125~270 mm, randomly distributed through the length of 2710 mm. Based on the detection of cracks and foreign particles, the rough machined ingot was rejected.

Figure 7. (a) A rough machined shaft that was rejected after UT inspection; (b) UT report locating internal cracks and foreign particle inclusions under duplicate measurements.

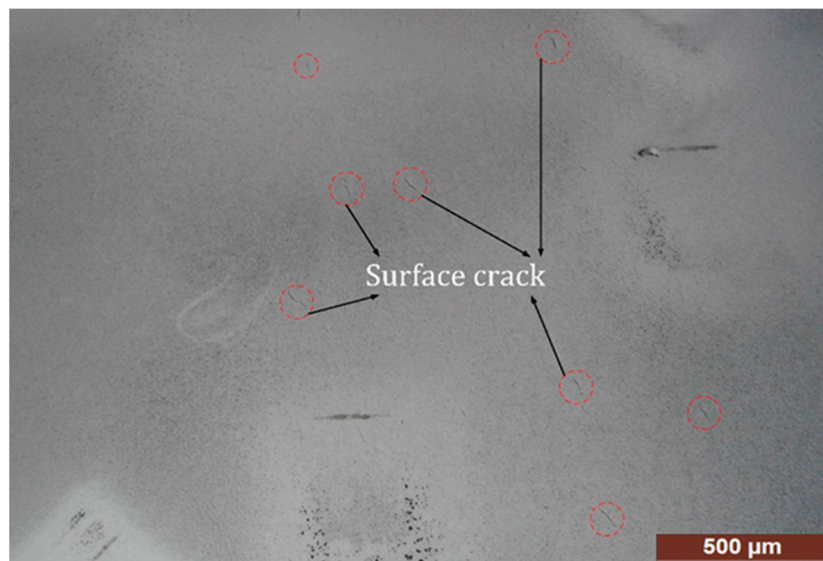
After preparing small size samples for destructive testing, magnetic particle testing was applied to detect discontinuities and crack dispersion on the specific portion of the shaft highlighted under UT. In the MT procedure, any distinct variation or discontinuity that distorted the magnetic lines, named flux leakage, was observed due to surface/subsurface cracks identified through a portable yoke system. Black iron particles were sprayed with liquid suspension, enabling the free flow of particles over the workpiece surface. Fine iron particles were accumulated at the poles of a magnet. However, in any discontinuity/crack, iron particles accumulated at the flaw/crack location and followed the same orientation as a flaw/crack pattern, making visible the cracks highlighted in Figure 8. This indicates that cracks are randomly distributed, as can be seen by the naked eye. MT verified the results of UT by highlighting subsurface cracks. However, the cause of cracks and the nature of foreign particles could not be detected through magnetic particle testing. So, further investigation was required to find the root causes of sub-surface cracks or non-metallic inclusions.

Figure 8. Surface cracks after performing magnetic particle testing.

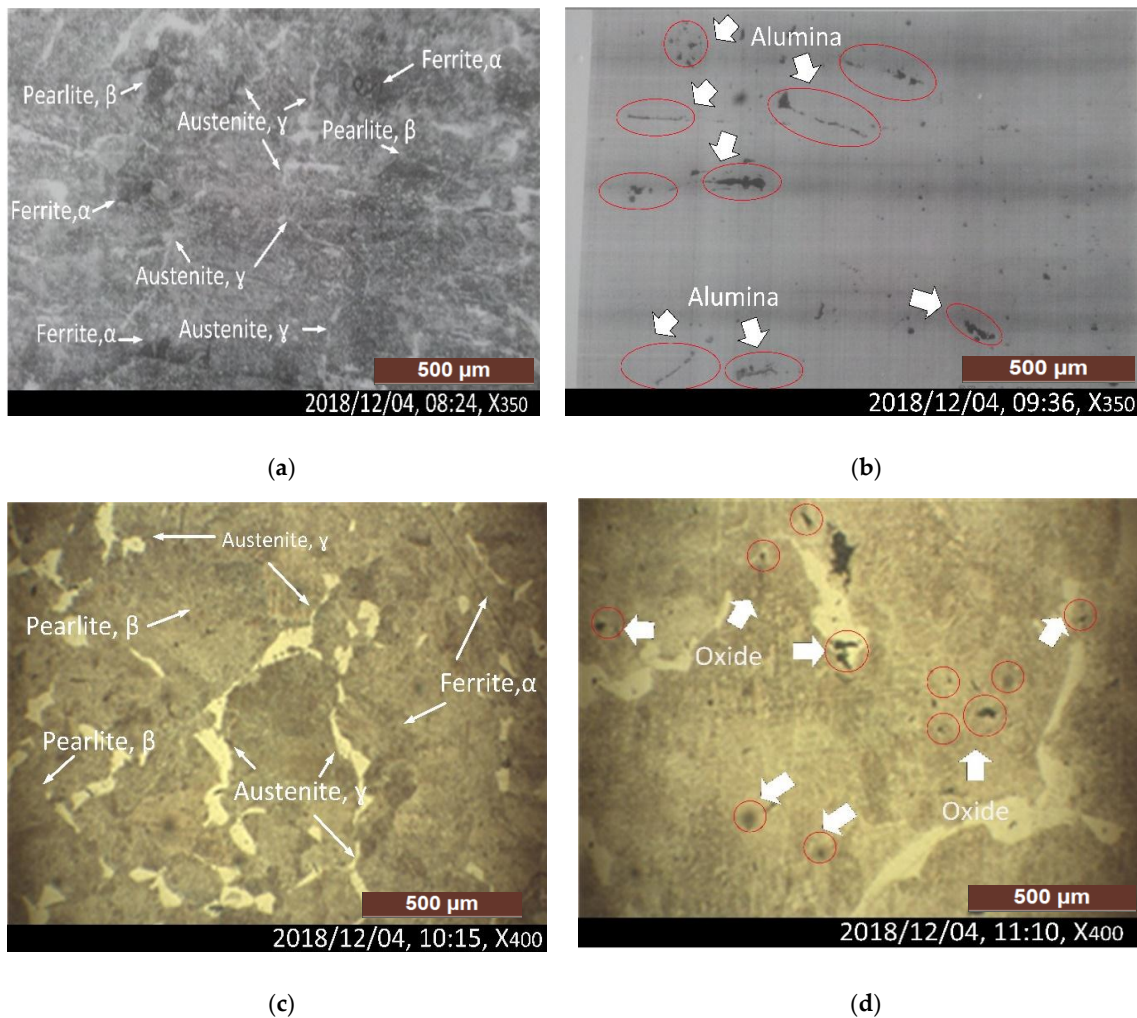
Figure 9a depicts that the as-cast structure contains ferrite within a fine pearlite matrix and at prior austenite grain boundaries. The randomly distributed grain structure depicts that there is no issue in the grain size or chemical composition at a magnification of $\times 350$. The grain size was determined in steel by ASTM (American Standard for Testing and Materials). Thus, steel with $N = 6$ has an average of 32 grains in an area of 1 sq. At $\times 100$. On the surface of the 42CrMo4 sample, a significant exogenous inclusion of aluminium oxide (Al_2O_3) was identified (red circles) on the surface and subsurface, which agreed well with the ASTM E-45 standard presented in Figure 9b. Similarly, at a higher magnification ($\times 400$), Figure 9c underscores the ferrite within fine pearlite at prior austenite grain boundaries, depicting the random distribution of microstructure components and confirming the composition. Also, small exogenous oxide-type inclusions were identified by comparing the inclusion trends with ASTM E-45, presented in Figure 9d.

Figure 9. (a) As-cast structure of ferrite within the fine pearlite matrix and at prior austenite grain boundaries, at a magnification of $\times 350$; (b) Not-etched micro alumina-type inclusions are observed as per ASTM E-45, at a magnification of $\times 350$; (c) A fine matrix structure of ferrite within the fine pearlite matrix and at prior austenite grain boundaries, at a magnification of $\times 400$; (d) Not-etched micro oxide-type inclusions, at a magnification of $\times 400$.

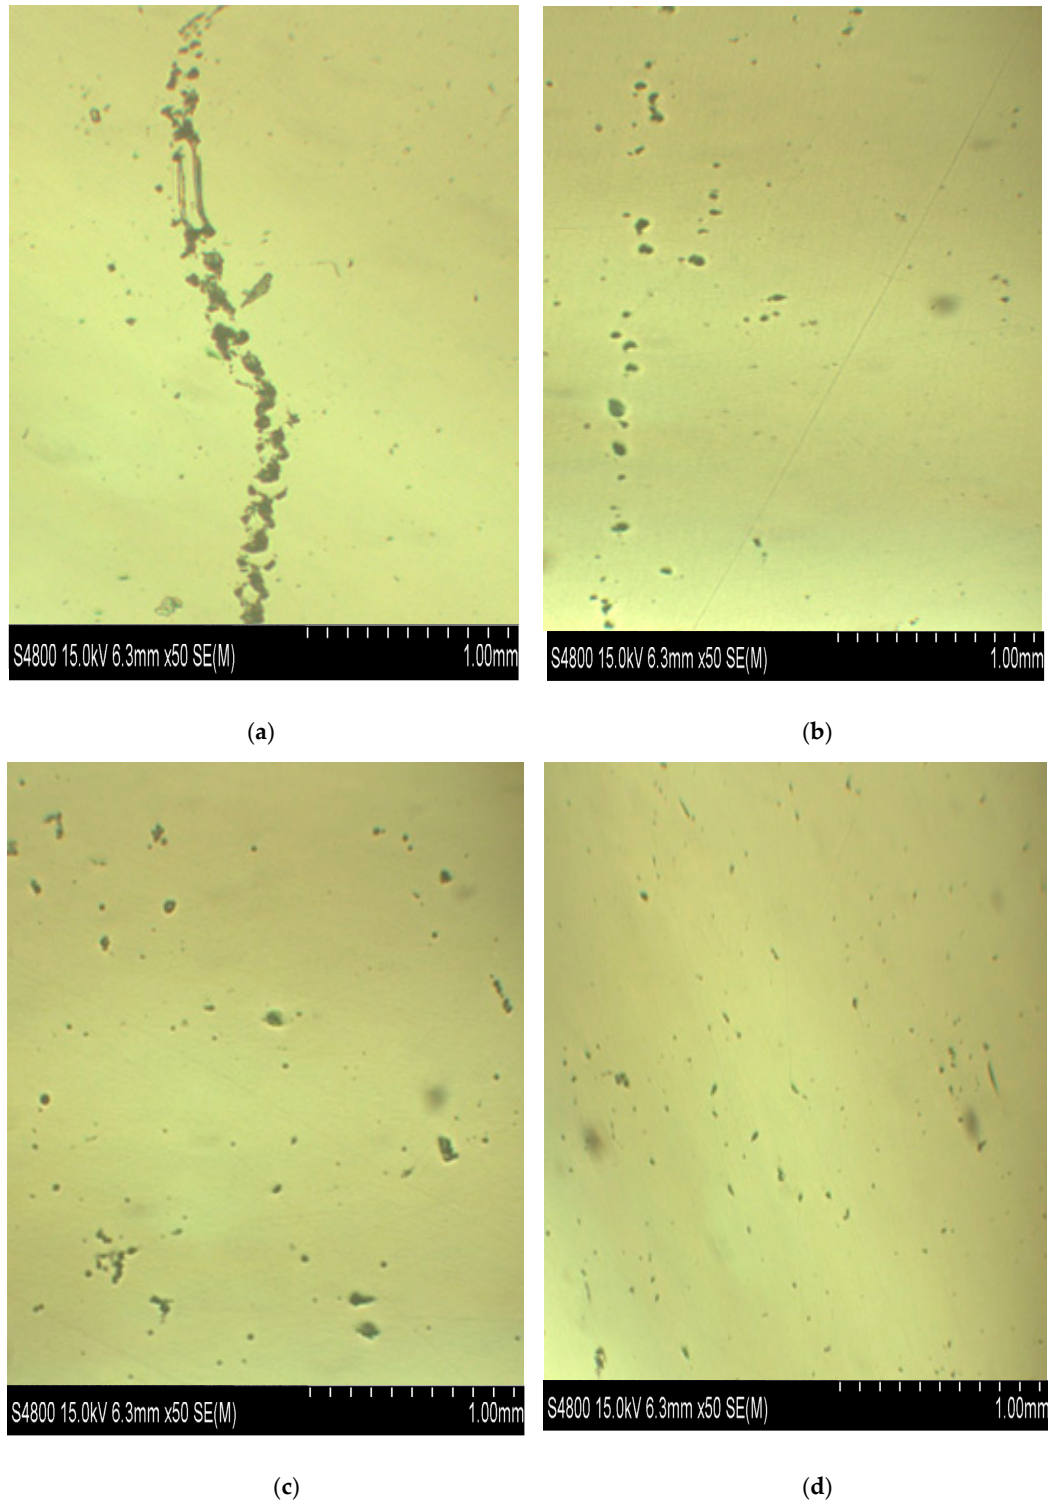
After the identification of alumina and oxide-type inclusions through ASTM E-45, SEM images were attained for further verification of the inclusions. The SEM images depicted alumina and oxide-type inclusions as foreign particles. Figure 10a,b depicts the alumina foreign particle inclusions. Figure 10a depicts the heavy series of alumina-type inclusions, with a thickness of approximately $15\mu\text{m}$. The depicted trend (Figure 10a) is compared with the Jernkontoret (JK) chart to determine the foreign particle contents in steel. The trend lies under alumina-type heavy series and level-3 reduction of standard E-45, by the permission of ASTM (American Standard of Testing and Materials). Figure 10b underscored the alumina-type inclusions with thin series having a thickness of approximately $9\mu\text{m}$. The specific trend lies under alumina-type thin series and level-3 reduction, according to standard E-45.

Similarly, Figure 10c, d depicts the oxide-type inclusions. Figure 10c depicts the oxide-type inclusions under heavy series with a thickness of approximately $12\mu\text{m}$. The specific trend of globular type oxide is compared with the Jernkontoret (JK) chart to verify the nature of the inclusions in the steel. The randomly distributed globular oxides showed no specific trend under oxide-type heavy series level-3, as per standard E-45 by the permission of ASTM. Besides, Figure 10d highlights oxide-type inclusions under thin series with a thickness of approximately $8\mu\text{m}$. This is randomly distributed globular type oxide level-3, according to standard E-45. The provided microstructure images for these

Figure 10. (a,b) Microstructure of sample indicating alumina-type inclusions, as per ASTM E-45, (c,d) Microstructure of sample indicating oxide-type inclusions, as per ASTM E-45.

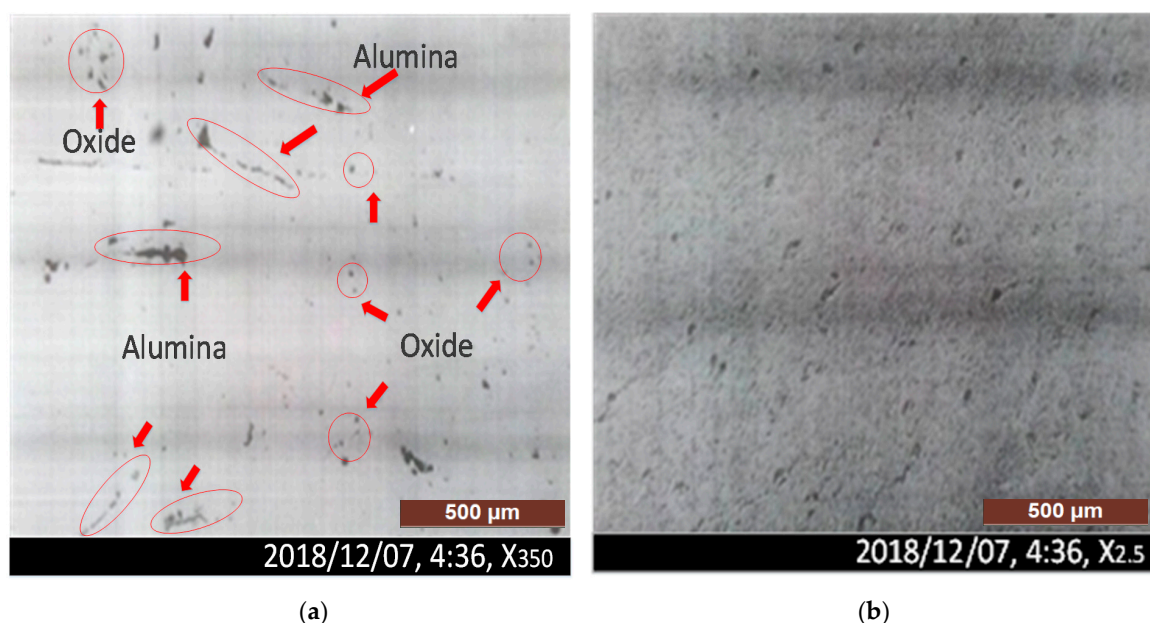
Figure 11a depicts the specimen under macroscopic observation, which revealed oxide and alumina-type inclusions, observed as per ASTM E-45 [37]. The specimen was polished without etching to observe the non-metallic inclusions. Findings depicted the presence of randomly distributed alumina and oxide-type inclusions. Besides, the sample was hotly etched in HCl (1:1), as inclusions were observed, randomly distributed as per ASTM E-381 [38]. The random condition is presented by R-5 (Figure 11b). By comparing the metallographic tests with ASTM standards, oxide and alumina-type inclusions were recognized. The refractory material of the ladle and roof of the furnace were the sources from which alumina-type inclusions were transferred to casting material. Low-quality flux was the primary source of oxide-type inclusions. These non-metallic inclusions have a significant contribution to shaft rejection [39]. By applying standardized procedures at each step, the failures can be reduced to a minimum.

Figure 11. (a) Micro-inclusions, oxide and alumina-type inclusions, observed as per ASTM E-45 (b) The specimen was hotly etched in HCl (1:1), as inclusions were observed and randomly distributed as per ASTM E-381. The random condition is R-5.

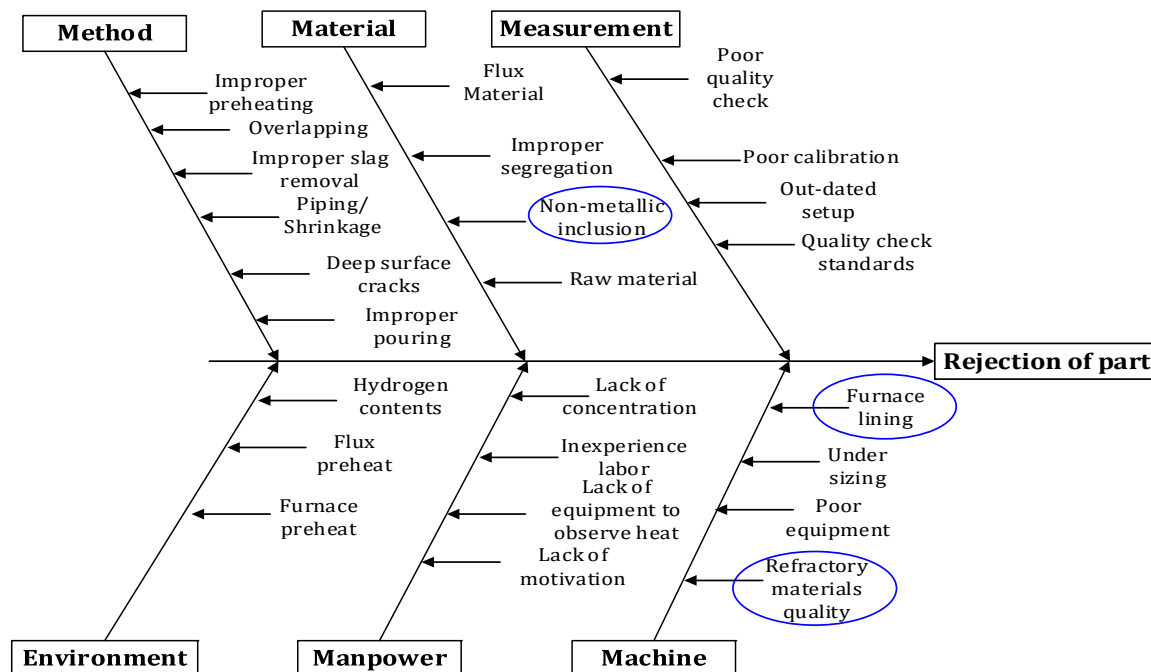
Jayswal et al. [42] used a Fishbone diagram, which is a robust tool for detecting the possible causes of defects. Therefore, a similar methodology was implemented in this research. It helped to reach the root cause of the problem, i.e., the rejected mill drive shaft. By using a Fishbone diagram, it is possible to identify the main possible causes, which are associated with hydrogen contents, improper segregation of raw material, non-metallic inclusions, piping, lack of concentration of employees, furnace lining, inexperienced employees, improper pouring, deep surface cracks and so on. This methodology was validated for the mill drives shaft 42CrMo4, having the length of 2695 mm and diameter of 635 mm. The results permit the indication of the root causes of defects in order to avoid product rejection during the quality tests. The primary purpose of RCA is to find the underlying source of the observed symptoms of a problem [43]. The RCA technique was used in this research to identify and eliminate the possible causes of defects. The main purpose of RCA in this research work was to determine the key factors which affect the working environment and root causes of failures. This can be achieved by observing the history of previous events. In this way, the production efficiency can be improved by eliminating the major causes of failures. Root causes of failures and deviations from qualification standards in manufacturing are usually identified based on existing on-site expert knowledge regarding causal relationships between process steps and the nature of failures and deviations [44]. Identification and backtracking of root causes for said failures and deviations is exceptionally beneficial in order to avoid recurrence of such failures in the future. Tolerance analysis is an important parameter to determine the performance of the manufacturing process. It enables the measurement of the maximum possible variation of a quality feature in a production process [45]. The quality of the workpiece is paramount, and sometimes it becomes the primary constraint for productivity. The quality of the parts depends upon many direct and indirect factors (Figure 12), and those with poor quality are rejected during the production. Figure 12 highlights the factors such as methods, materials, measurement, environment, and other evaluation elements that affect the quality of a workpiece, such as the one tested in this study. Based on microstructure and SEM analysis, the root causes of rejection were highlighted. The proposed approach in this work is mainly based on achieving an integrated and solid analysis of such evaluation elements, and this approach showed a promising role in highlighting all possible problems/challenges associated with each element. Therefore, the single and interactional effects related to these problems were obtained, and this can support the decision to accept or reject any part by applying such a proper and practical approach. It should be stated that the proper application of such a technique and methodology helped to prevent such failure problems, and it is found that the reduction in the rejection rate for defective production was 7.6% after implementing the proposed failure detection approach.

Figure 12. Cause and effect diagram highlighting the causes of shaft rejection.

Furthermore, as a correction process, the furnace lining, lining of the hot-top of the furnace and ladle were replaced with a better quality of refractory material. The feedback was collected after two months, and the rejection rate was reduced to 6.67% as only one shaft was rejected out of 15 during the process of the current research. Through a proper implementation that makes a quality standard for the entire system procedures, the rejection rate can be reduced further. These recommendations were implemented in heavy mechanical industry [46]. The drastic change in the rate of rejection was associated with the identification of root causes of failure and moving the system towards the application of standardized procedures. Further, by controlling the percentage of inclusions/impurities at each step, the rejection rate can be reduced as well. Moreover, waste management also plays an important role in manufacturing processes. To sum up, the single and interactional effects were obtained, which support the decision to accept or reject any part by applying such a proper and practical approach. It should be stated that the proper application of such a technique and methodology
